Ecological landfills for municipal waste

Valentin Feodorov

Abstract. The paper deals with the conclusions drawn from the design, construction and operation of 28 ecological landfills for municipal waste achieved in Romania from 1995 to 2012 within the European Program. It comprises an introduction into waste management in Romania, the European and national legislation used for landfills, design principles applied for the ecological landfills, the design of new municipal landfills for non-hazardous waste, criteria for choosing the sites in terms of land topography, in compliance with geological/geotechnical conditions, Case Studies – Bistrița Project Location of the CMID Dumitra–Târlău, the impact of conclusions provided by two reports of technical expertise regarding the solutions of the initial projects, the geological barrier and the impact on the operational phase of the landfill CMID Târlău. The paper concludes with technical recommendations for projects of ecological landfills based on the experience gained in previous years, but also for the construction and operation of such important infrastructure with higher performances.

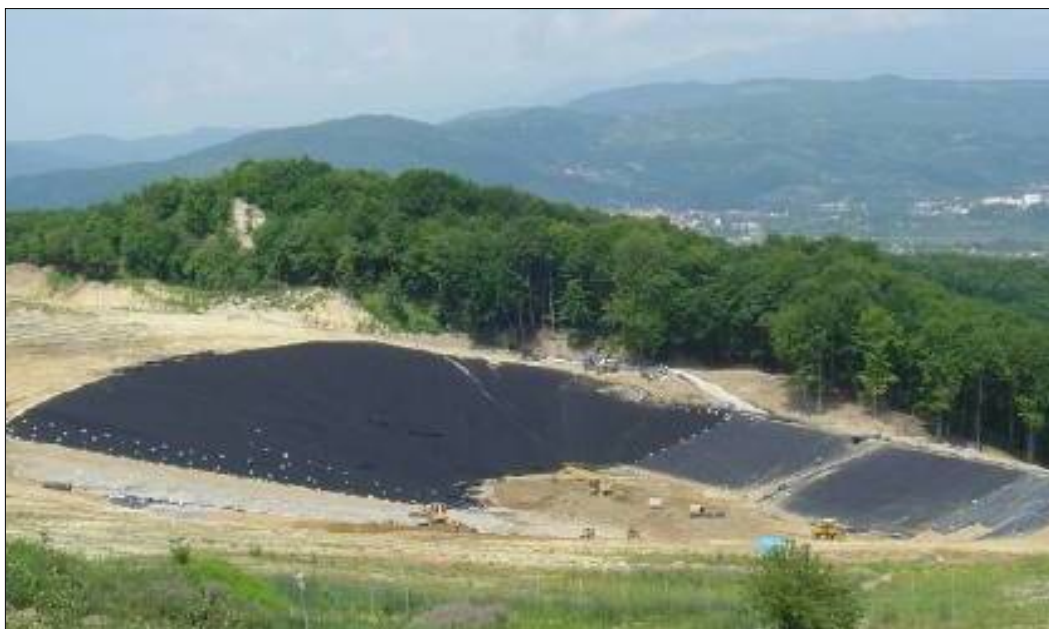
Figure 2. Construction of the landfill at Feteni, Râmnicu Vâlcea.

The Feteni, Râmnicu Vâlcea location is characterized by steep slopes, active landslides and difficult access of the vehicles belonging to the waste collection operator, in winter time.

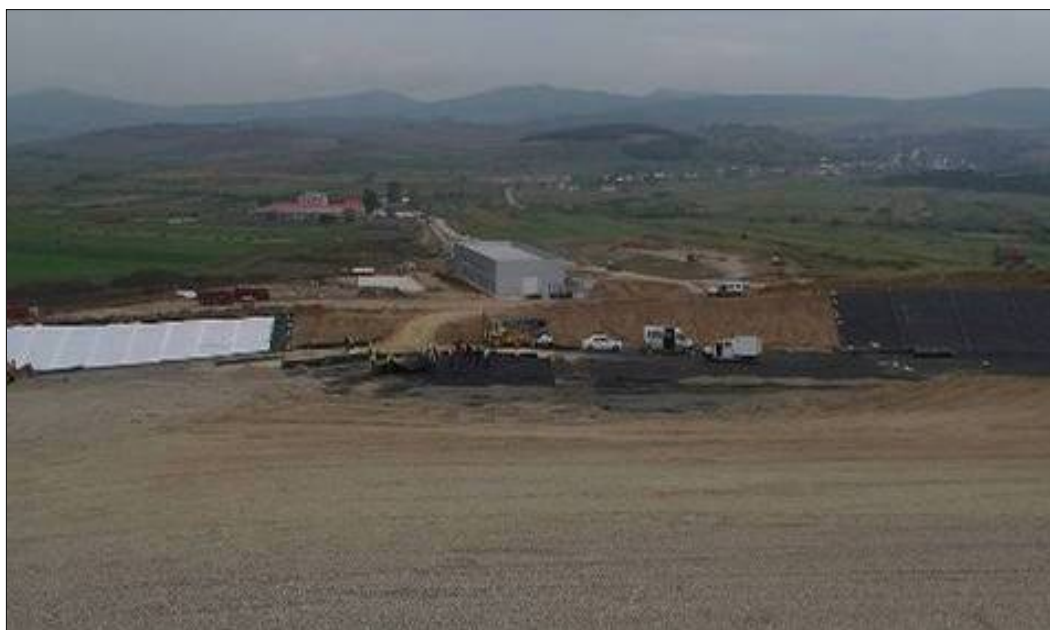
At the start of excavations on site, in March-April 2010, different geotechnical and hydro-geological conditions were detected and varying in certain areas, compared to those known from previous studies that the design was based on (Argif Proiect 2011; Manea 2010; Manea & Olin 2011) (Figure 3).

Figure 3. Centre for Integrated Waste Management at Dumitra-Tărbu during the landfill execution.

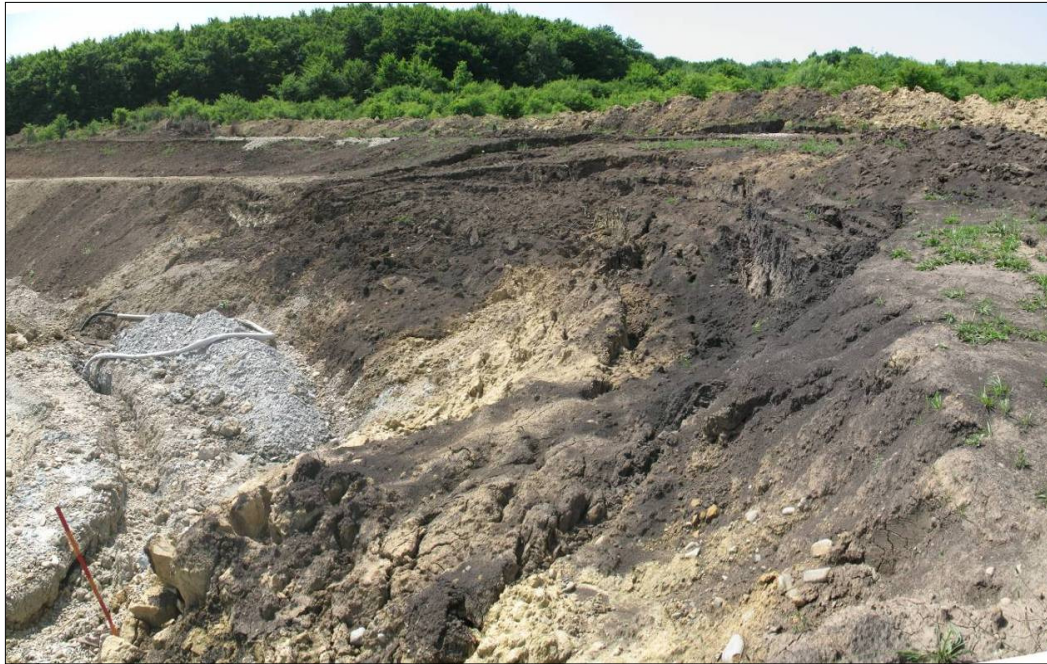
Later on, during the execution of earthworks for the composting platform area, although all precautionary measures had been taken, landslides in slopes were visibly reactivated (Figures 4-6).

During the execution, new geotechnical studies were carried out which revealed an old natural valley, known as Rosna Valley, which had been completely covered during a previous landslide.

Figure 4. North-West corner of the Dumitra-Tărpiu site, landslide reactivation.

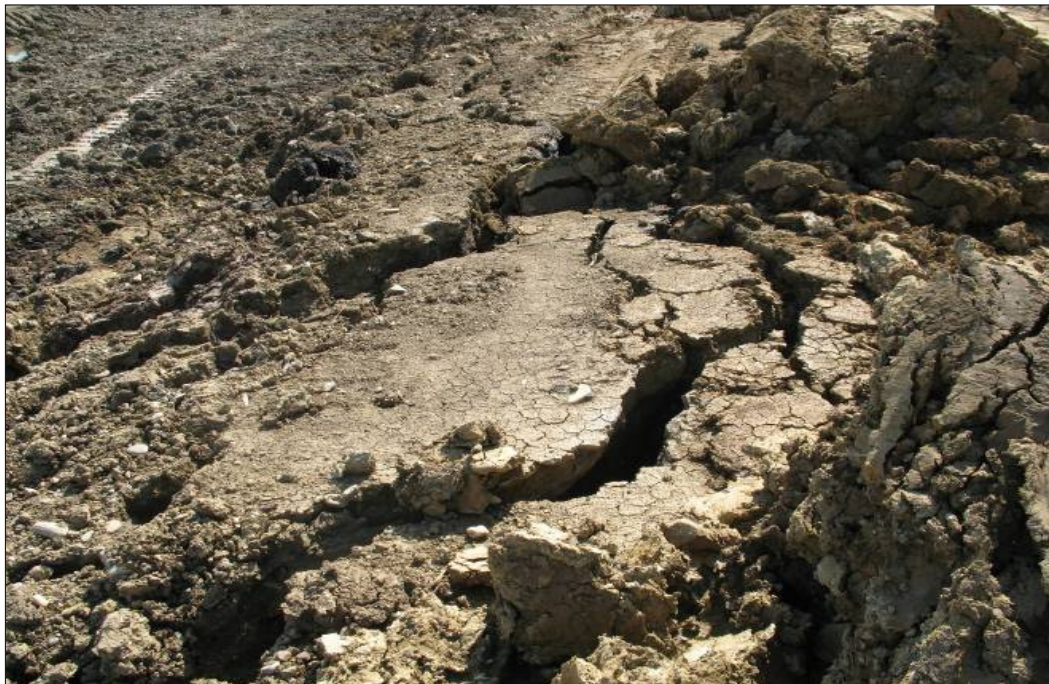
The displacement of earth mass at the Dumitra-Tărbu site occurred on the slope of the plastic materials storage-platform. The earth material was glomerular destructured clay.

Figure 5. Displacement of the earth mass at Dumitra-Tărpiu.

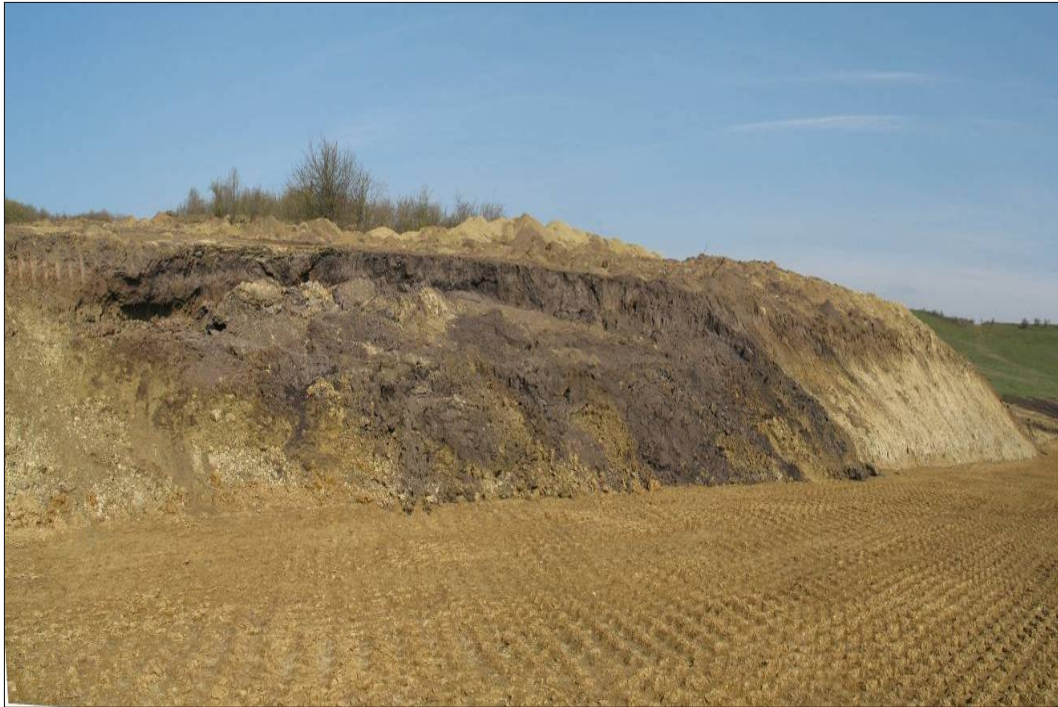
Figure 6. Confining area of the Western dike at Dumitra-Tărpiu storage cell no. 1.

Figure 6 shows the landslide repair works in the area of the plastic materials storage-platform.

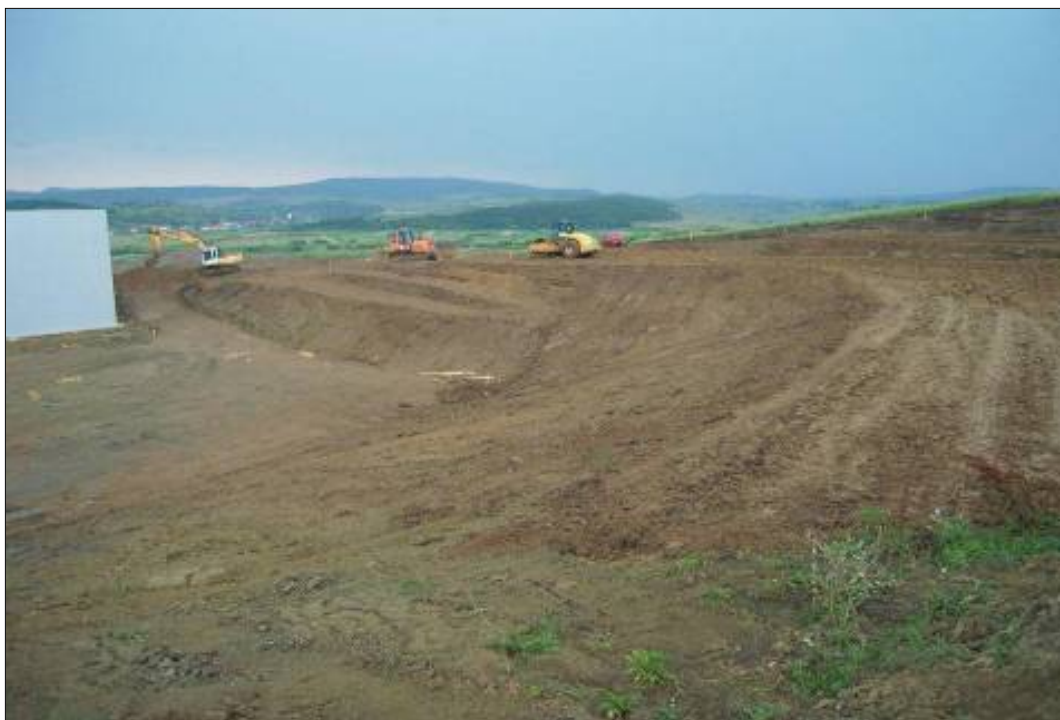
Figure 7. Slope repair between road DA2 and the plastic materials storage-platform.

- redesigning of all the constructions from the vicinity of the dam closing the landfill, the composting platform, plastic material storage platform and leachate treatment complex (Figure 7), taking into consideration that they were placed at different levels and the slopes occupy a considerable surface. This surface was not considered in the initial project.

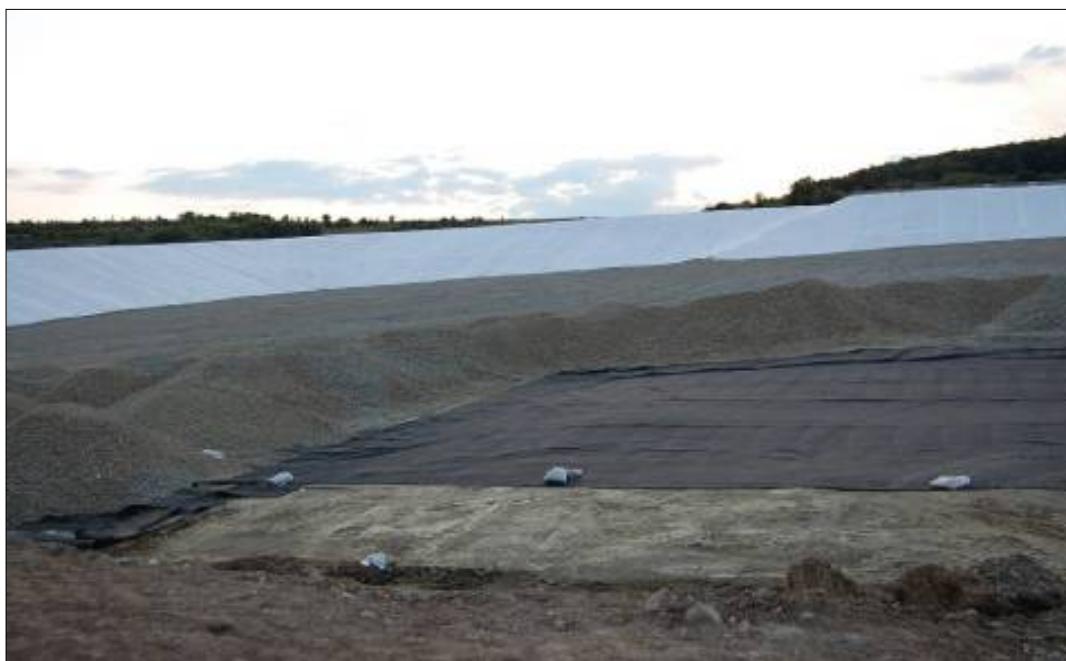
Figure 8. Installation of the waterproofing system at Dumitra-Tărpiu.

- a geological clay barrier with a minimum thickness of 1.0 m and a minimum value of 10^{-9} m/s for the coefficient of permeability;
- a 2 mm thick HDPE geomembrane;
- a drainage layer for leachate, with a thickness of 0.5 m, using sort 16/32 river gravel (Figure 8).

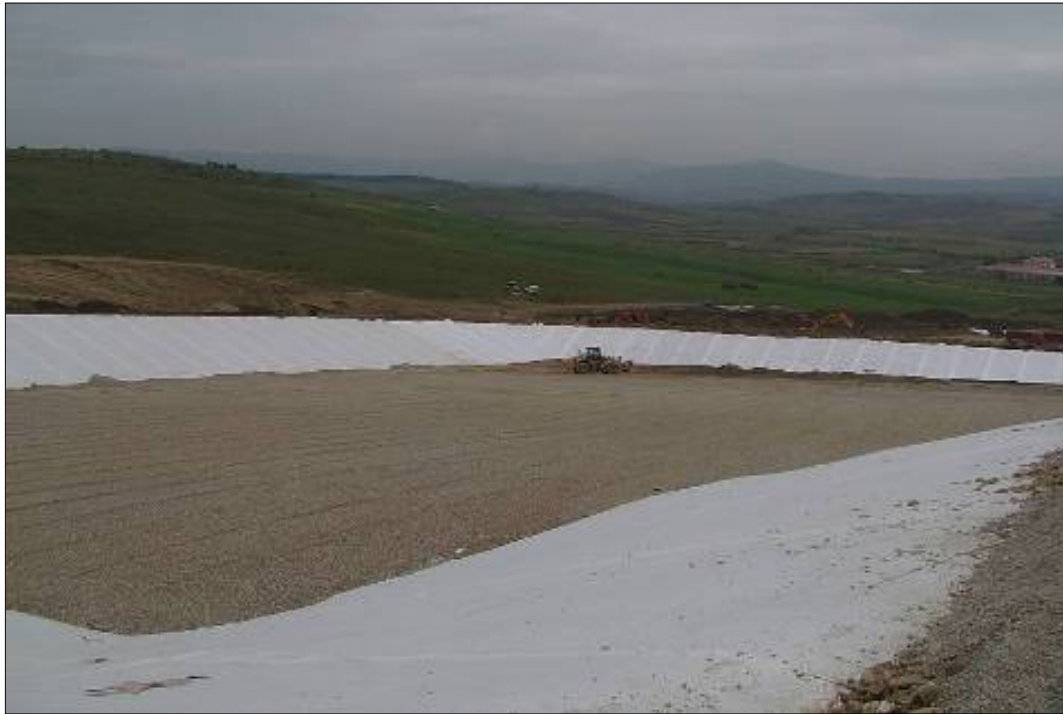
Impact on the operational phase of the CMID Tărbuș landfill. The Bistrița Project is the first project financed through POS Environment which was implemented (Figure 9). Choosing a location with problems has repercussions both on the operational phase and the execution phase of the works. In case of the CMID Tărbuș, the operator will subsequently:

Figure 9. Cell 1 of the ecological landfill at Dumitra-Tărbuiu.

- take over the monitoring of sliding phenomenon, which may occur especially on slopes, on the side road;
- intervene with specific works of slope consolidation, removal of the surface water, preventing cracks during drought periods;
- maintain the grass carpet and the protection of the plantation, recover them whenever necessary;
- maintain the channels of surface water discharge and the inspection chambers;
- keep in operation the entire drainage system.

The operator will have to be endowed with specific equipment for the execution of such works. It is recommended that he performs a study regarding the slope stability on the perimeter road, which requires a viable design solution for their stabilizing and probably a need to purchase additional land, to allow the execution of such works.
